City of Robinson Reservoir • Robinson, TX - USA

Community doubles water supply with Firestone GeoGard™ EPDM lined reservoir

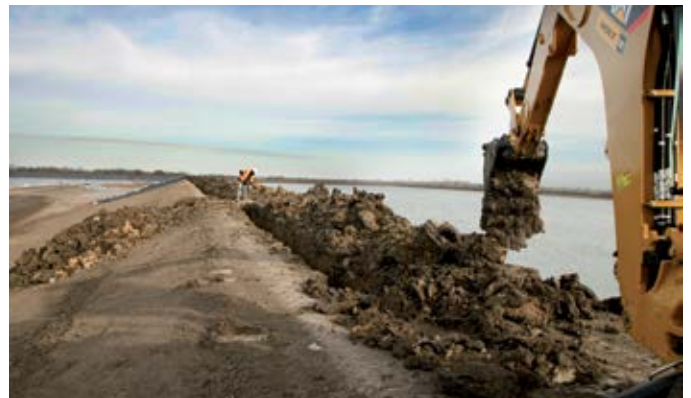
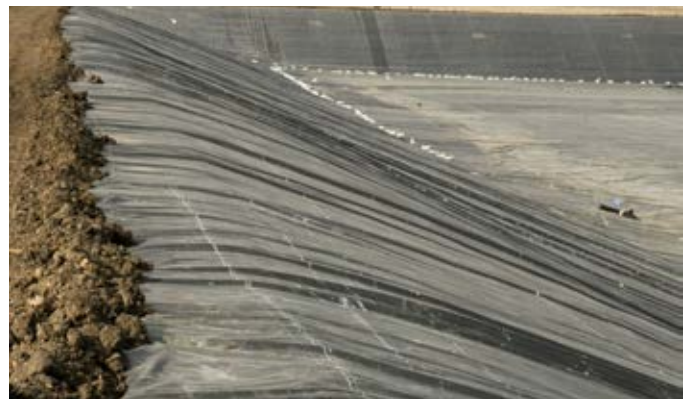
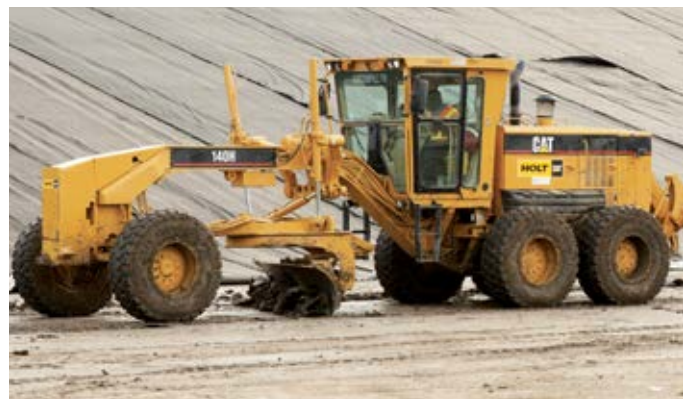
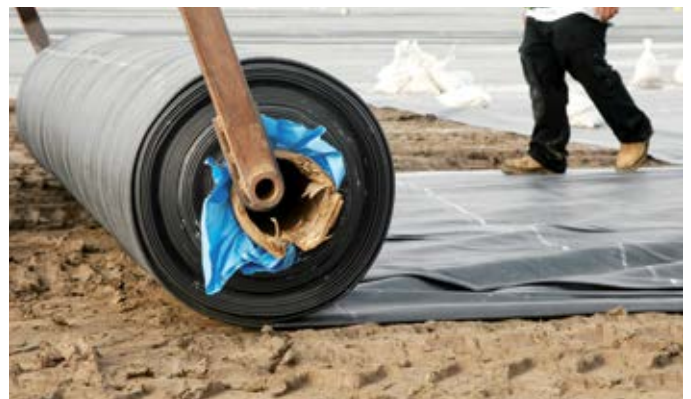
Geosynthetics Inc. (GSI), Waukesha, Wisconsin, installed the liner. The crew first installed a geotextile. Then, the geomembrane was unrolled in slightly overlapping 15,25 m by 61,00 m panels down the 3:1 slopes. The EPDM panels were seamed with Firestone QuickSeam™ Tape to ensure a watertight seal. Pipe boots and batten strip were installed, where necessary.
