Firestone GeoGard™ EPDM membrane provides Cost-Effective Solution for Irrigation Canal

Greenfield Irrigation District • Fairfield, MT - USA

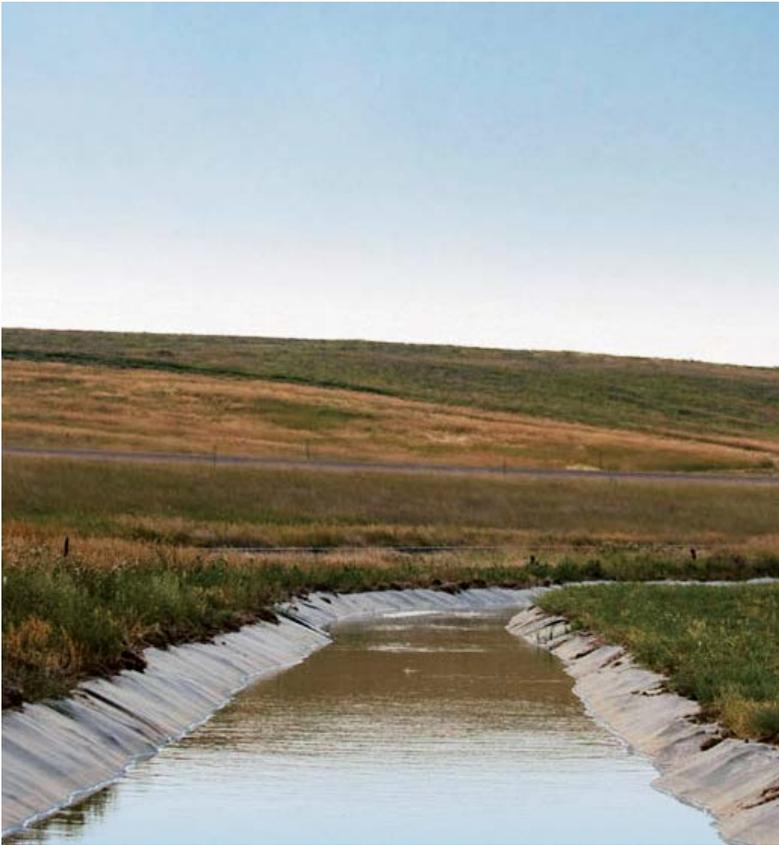
The Greenfield Irrigation District in Fairfield, Montana provides much needed water to area farmers, whose crops would otherwise suffer due to the region's lack of rain. After losing water in earthen and cracked, concrete canals, the district decided to rehabilitate an 8,21 km section of canal.

- Excavate 1 m - 1,2 m deep and 7,50 m - 9 m wide
- Install 74.300 m² of 1,1 mm Firestone GeoGard™ EPDM
- Install cross trenches and cleanouts at intervals along the canal

The cross trenches were prepared by digging across the canal at 152 m intervals. Each trench is 0,60 m deep by 1,20 m. The liner was placed across the trenches and anchored into place with large rocks.

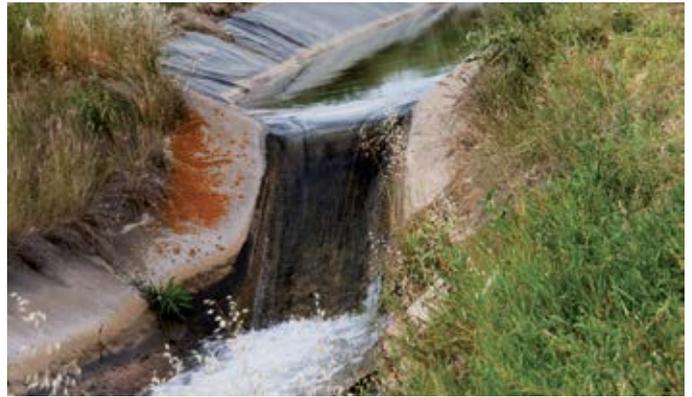
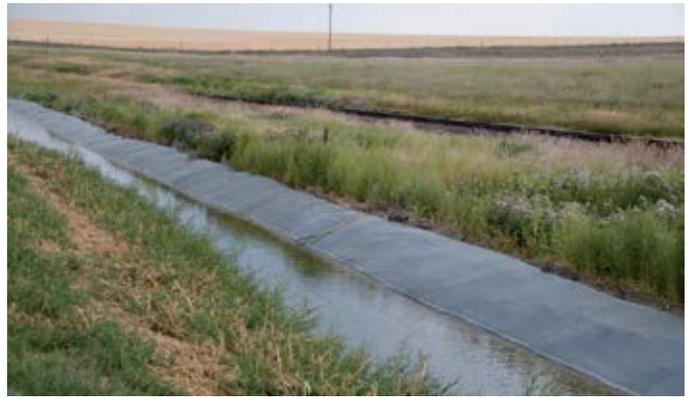
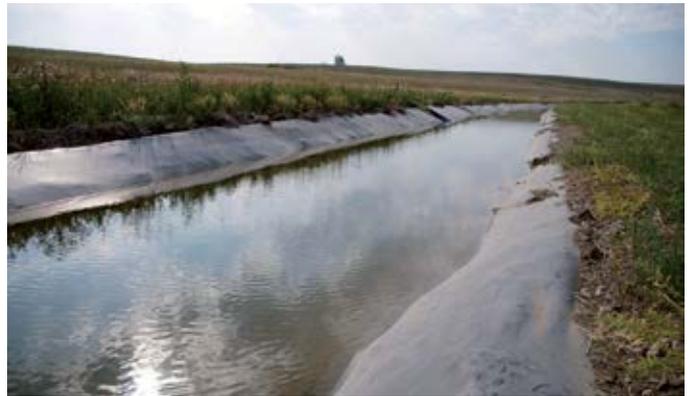
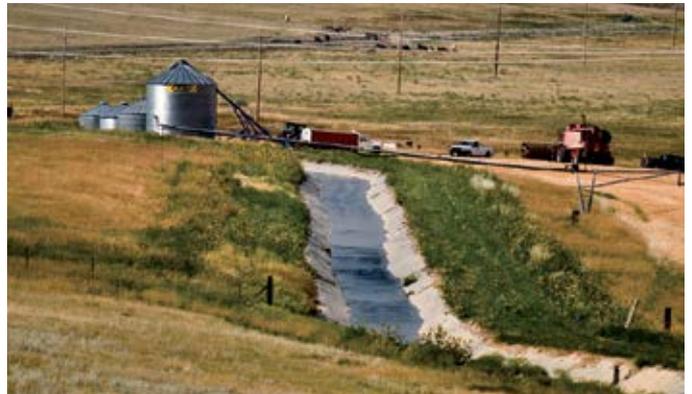
Irrigation district personnel served as the installers. Once they excavated the canal, a geotextile was laid into the bed. Next, the 9,15 m wide by 61,00 m long EPDM panels were unrolled down the center of the canal and unfolded up the sides. The panels were seamed together using Firestone's QuickSeam™ Tape System. The edges of the liner were then placed into an anchor trench and covered with dirt to secure them.
